# DEMONSTRATION OF THE AIR FORCE SITE CHARACTERIZATION AND ANALYSIS PENETROMETER SYSTEM (AFSCAPS) AT DOVER AFB IN SUPPORT OF THE INTRINSIC REMEDIATION (NATURAL ATTENUATION) OPTION

**April 1994**

ARA Report No. 5868-322 May 4, 1994

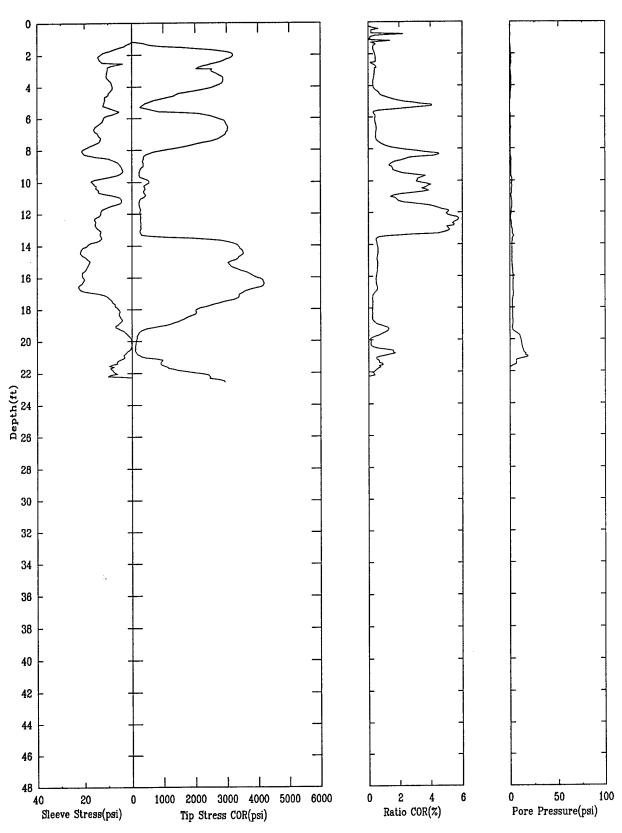
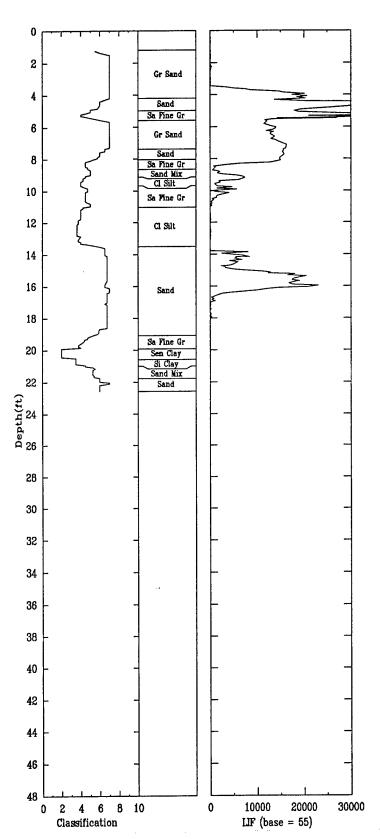
Figure 4. LIF-CPT profiles for XYZCPT-14-LIF.

A typical penetration profile from Dover AFB is presented in Figure 4. This profile (XYZCPT14-LIF) was completed to a depth of 22.5 ft and is representative of the geologic conditions at Dover AFB. This profile includes the sleeve stress, tip resistance, friction ratio, penetration pore pressure, and baseline LIF counts measured during the test, along with the soil classification and soil stratigraphy calculated from the data. For location XYZCPT14-LIF, the friction ratio profile is variable, which indicates that the deposits consist of stratified clays, silts and sands, and mixtures thereof down to approximately 13.5 feet. Between 13.5 feet and 19 feet there appears to be a lens of silty sand showing a maximum density at about 16.5 feet. Based on the tip stress, the density decreases uniformly from 16.5 to approximately 19.3 indicating a looser/softer material. From 19.3 to 20.8, the log indicates a stratified sand/clay/silty clay material. This can be clearly seen from the rapid increase in pore water pressure caused by the displacement of the soil by the cone. The pore water pressure increases above the static pressure because the hydraulic conductivity of the fine-grained soil does not allow the pressure to dissipate rapidly. From 20.8 feet to 22.5 the density once again begins to climb, and although not illustrated on this log, previous soundings typically indicated that this is the beginning of a dense gravel lens.

The LIF profile for XYZCPT14-LIF (Figure 4) shows a significant response beginning at approximately 3.5 feet below ground surface (bgs). Maximum values greater than 30,000 LIF units were noted in the sand seam between 4.3 and 5.5-feet bgs. This response is equivalent to the response of liquid phase JP-4 used to calibrate the laser. The LIF response continues to decrease reaching the baseline value (55 units) at 11 feet bgs. This depth coincides precisely with sand (fine grain)/clayey silt interface. Studies have shown that high clay content can attenuate LIF response that may explain this result. At 13.6 feet bgs the LIF response again shows a significant response, albeit lower than above, increasing to a maximum value at 16 feet bgs, then decreasing to baseline at approximately 17 feet bgs. No further response was noted in this profile.
